## **Summary of the King County, Washington, West Point WWTP Flood of 2017**

**Brian Lee Mast, P.E.  
Copper Bell Consulting LLC  
Seattle, Washington  
brian@copperbell.net**

**2018 ISA Water/Wastewater & Automatic Controls  
Symposium (WWAC)  
8-9 August 2018, Bethesda, Maryland USA**

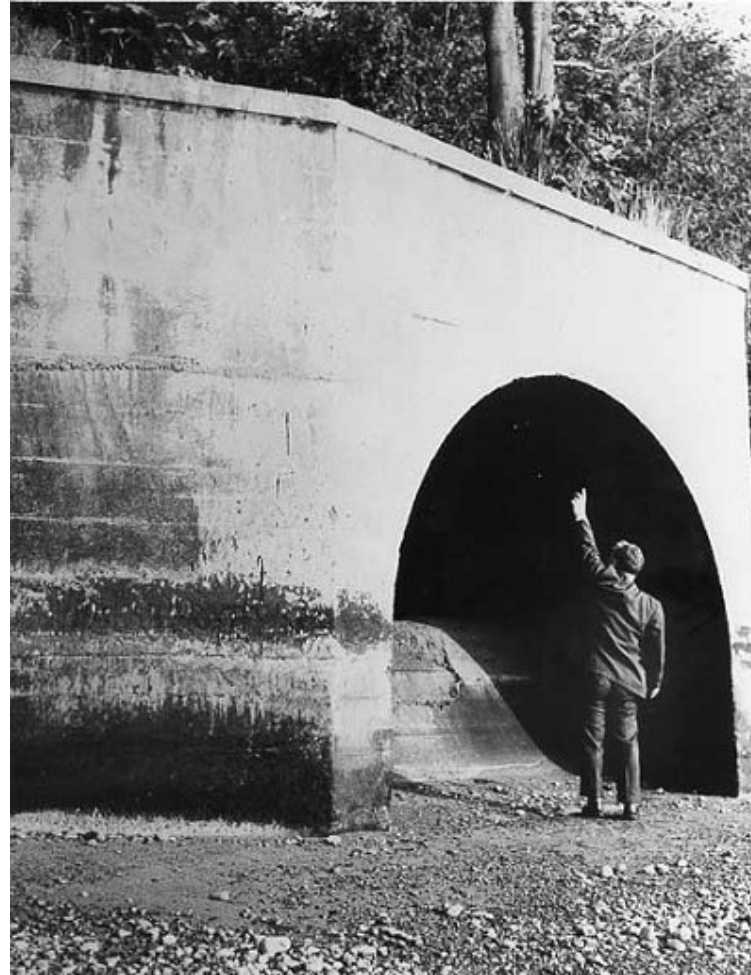
# The twelve foot pipe!

- 1884 City Engineer Reginald Heber Thomson – Lake Union and Washington getting polluted
- Find somewhere else to dump sewage!
- 1904 studies found West Point beach had nice outgoing currents
- 1918 a 12 ft. diameter pipe discharged there 45 ft. below high tide (still not nice on beach)
- Dumped raw sewage combined with storm water runoff until mid 1960s

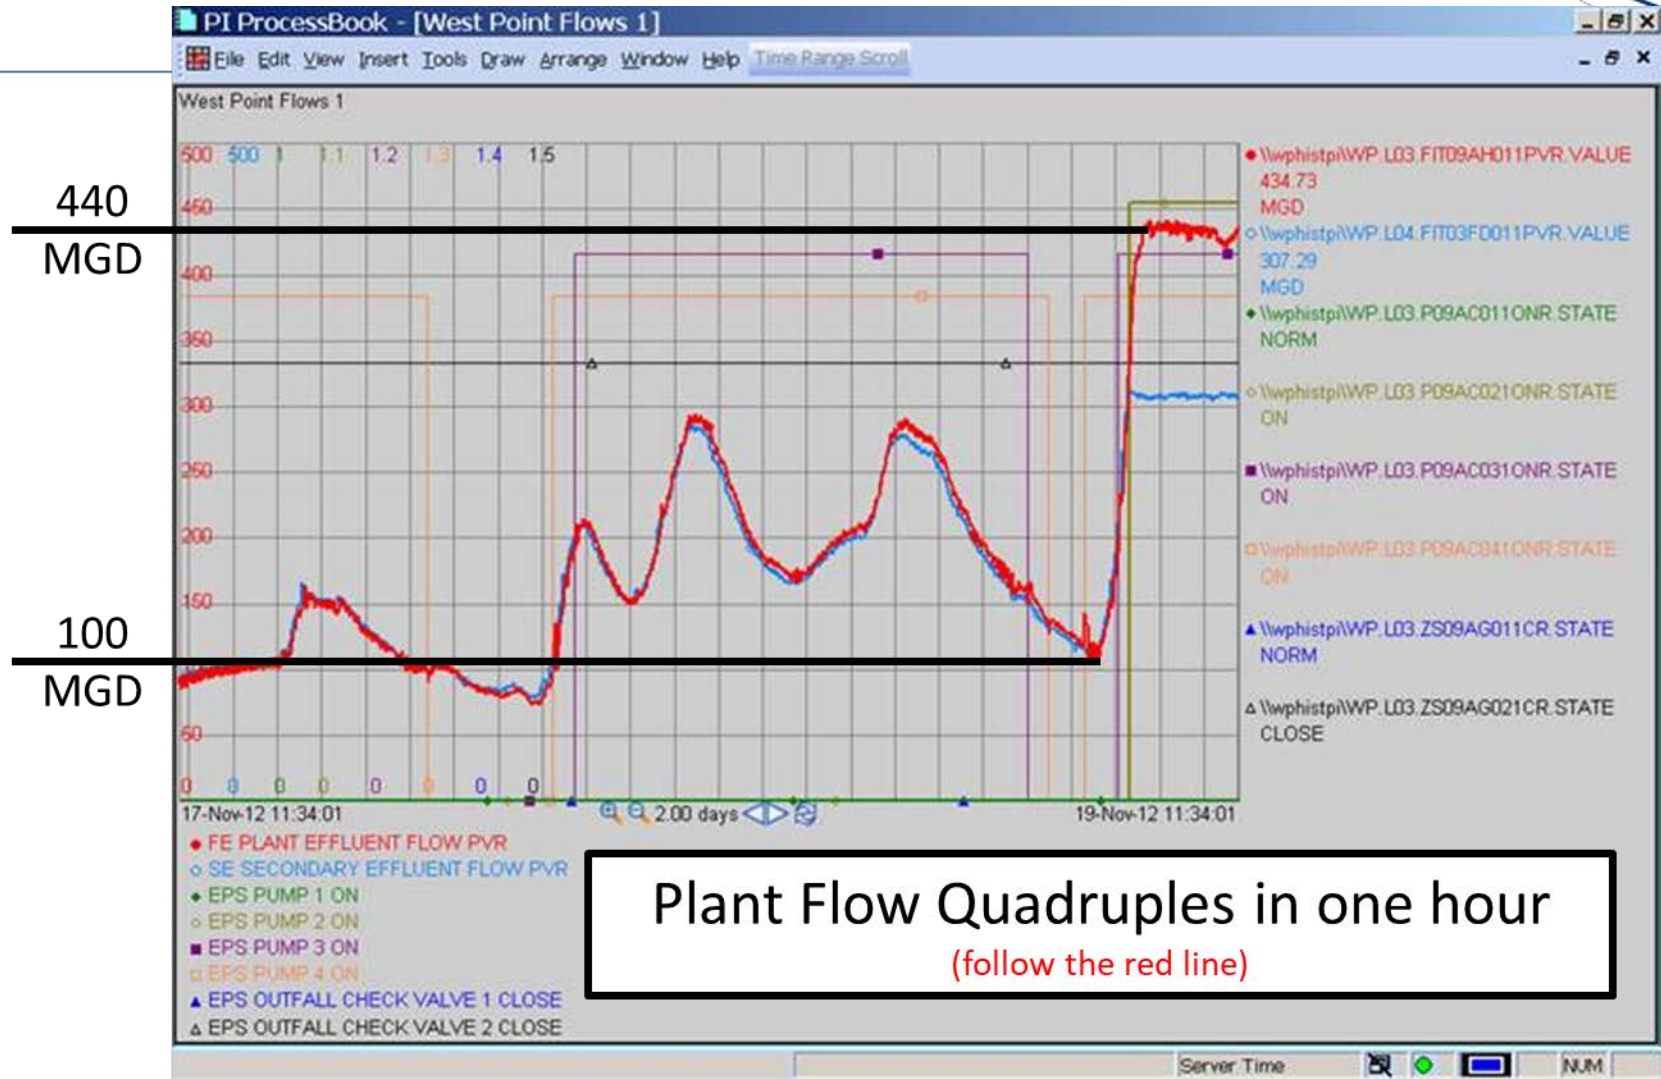
# Extreme flow rate increases possible

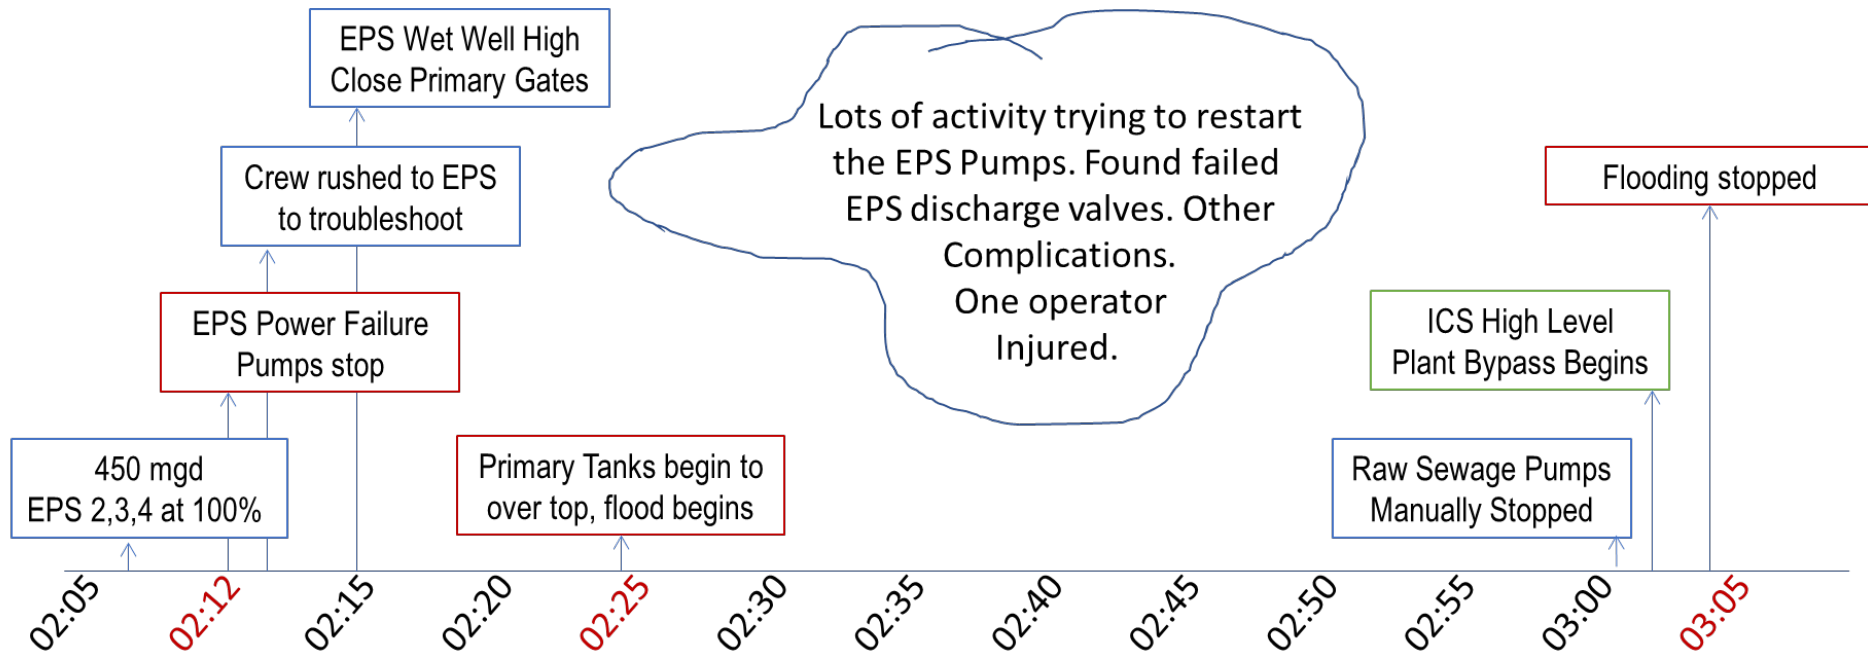
# Event timeline

- Motor Control Center power fault caused 2 Effluent Pumps to fail
- Critical valve controls also powered from same Motor Control Center – common to all valves
- Effluent Pump Station reached High level – This closed weirs at the Primary Tanks
- Primary Tanks began to fill and started reaching High levels
- Critical level float switches failed to shut down the Raw Sewage Pumps
- Levels rose and overtopped the Primary Tanks causing flooding to the plant galleries
- Operators stopped Raw Sewage Pumps, Influent Control Structure level rose to High
- Influent Control Structure float switches triggered plant bypass
- Hundreds of control system alarms flooded the operator’s graphic screens

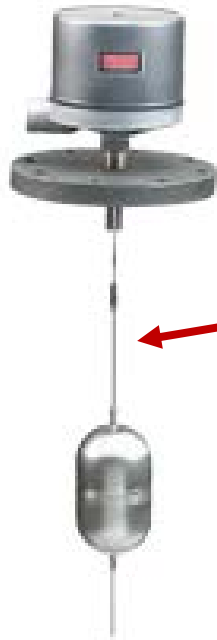
# Primary tanks high level float switches

The Mercoid Series 301, explosion proof switch

Why did 12 of these all fail at the same time?

All the important high level switches in the Primary Tanks failed because these rods got bent during regular maintenance and cleaning.

It was being done wrong.

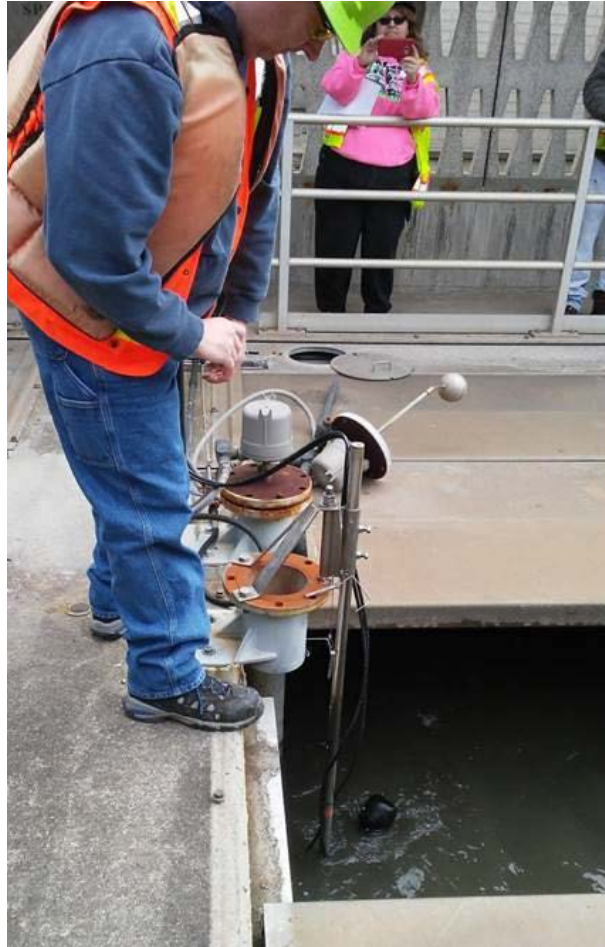
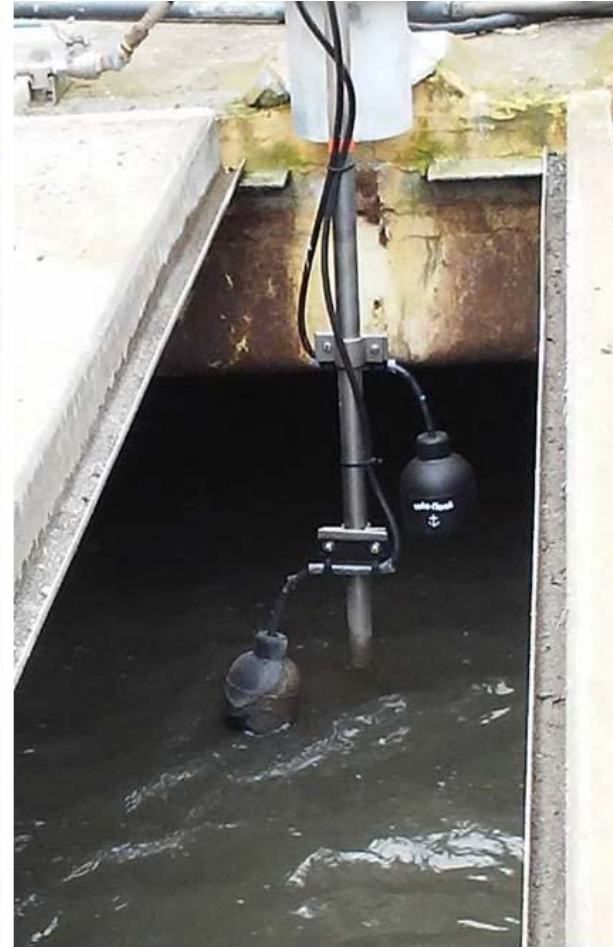
# Old and replacement high level float switches
